# **TREE SURVEY 2010**

### Of Trees Planted by the Holliston Garden Club 1953-2010

**The Holliston Garden Club  
P. O. Box 5812  
Holliston, MA 01746**

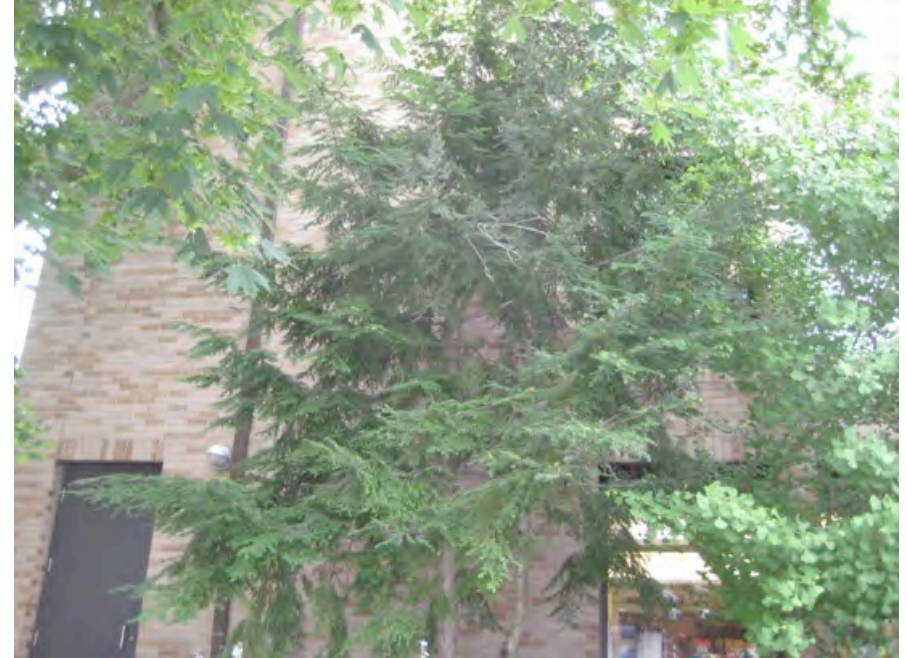
**Tsuga canadensis, Photo Dated June 19, 2009**

The tree has two trunks. Recommend removing one trunk to allow for light and better growth and appearance; or, to create a better environment for all the trees, remove this one completely. This would create better conditions for the Ginkgo biloba next to the hemlock. The tree is not particularly attractive and adds little to the area, which is already too narrow to support so many large trees.

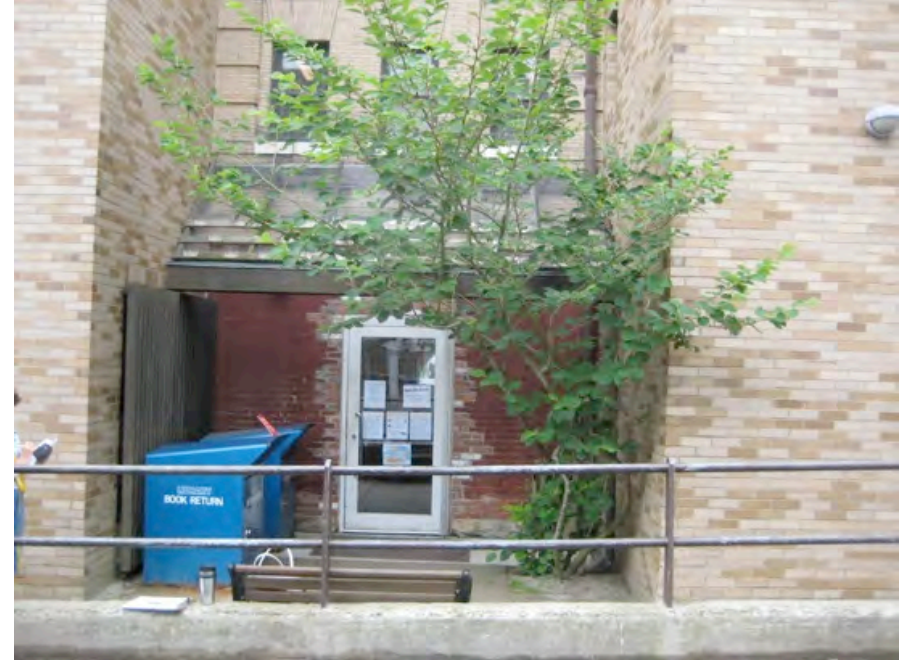
**Hamamelis brevipetala, Photo dated June 18, 2009.**

Multi-trunk tree, with some suckers that need to be removed. Tree also needs heavy pruning as it has outgrown its space. The planting area should be enlarged and the soil replaced, then mulched. The tree blooms every winter and makes a nice display, so it appears to be healthy.

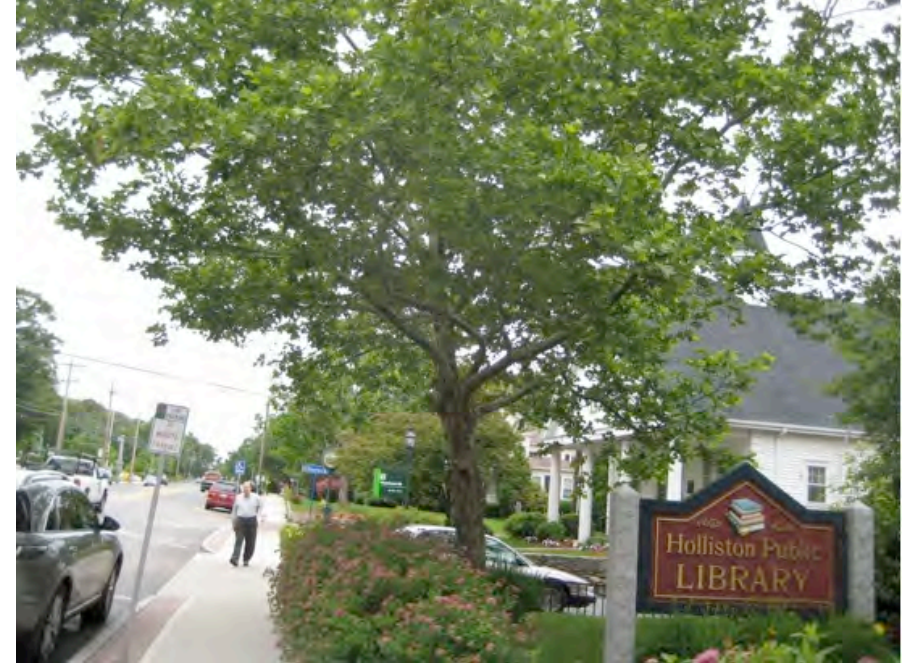
**Platanus acerifolia, Photo Dated June 18, 2009**

Tree is lovely, good condition but needs some pruning.

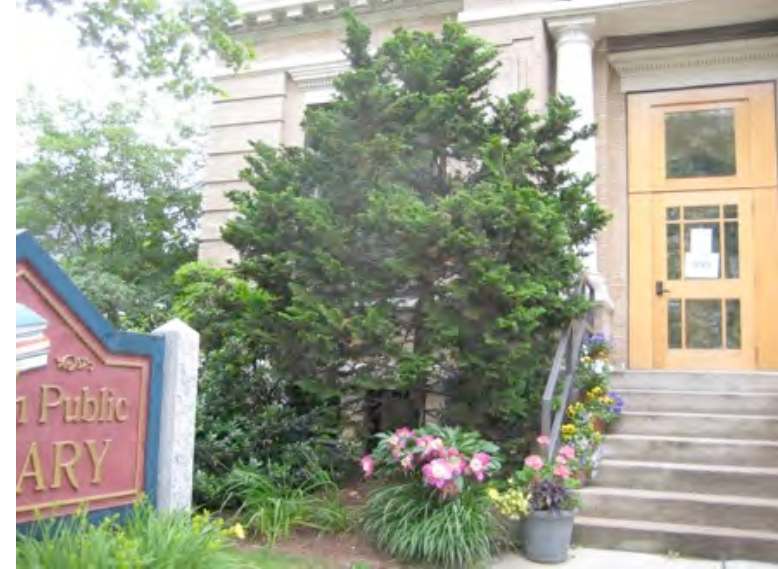
Chamaecyparis gracillis, Photo Dated June 18, 2009

I.D. Tag or Stake: Tree is to be replaced at request of Library because it is blocking out front lighting.

Healthy, full tree. A peony beneath needs light and room to bloom. The base is covered with too much mulch. This is a moot point because this tree and its companion are to be replaced.

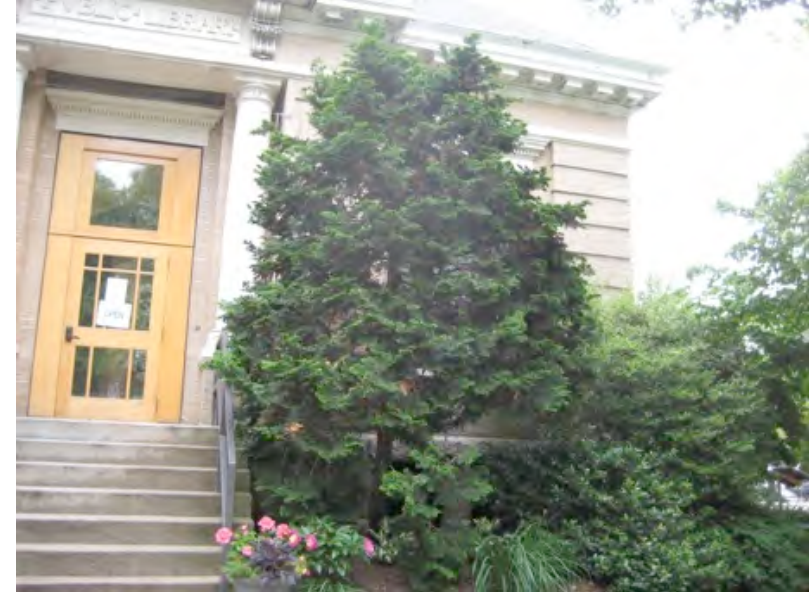
**Chamaecyparis gracillis, Photo Dated June 18, 2009**

In good shape but needs regular pruning to properly frame front entrance and to make room for the peony beneath it. Also, there is too much mulch around trunk. Tree will be replaced.

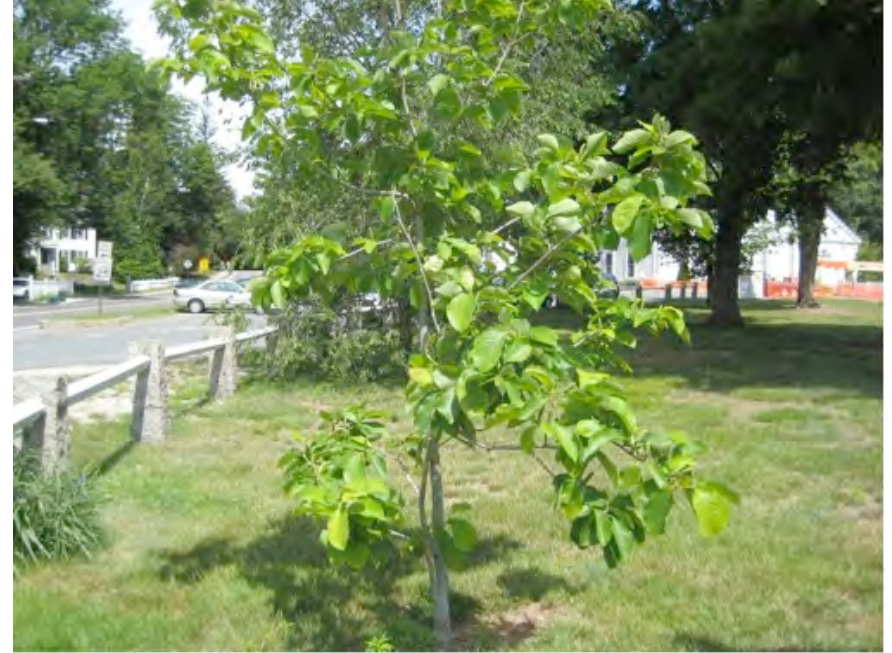
**Magnolia Elizabeth, Photo Dated June 17, 2009**

Area around tree is small and compacted, with some grass growing close to the tree. Needs to be enlarged and loosened. Leaves have some insect damage. General tree condition is healthy although tree is growing very slowly.

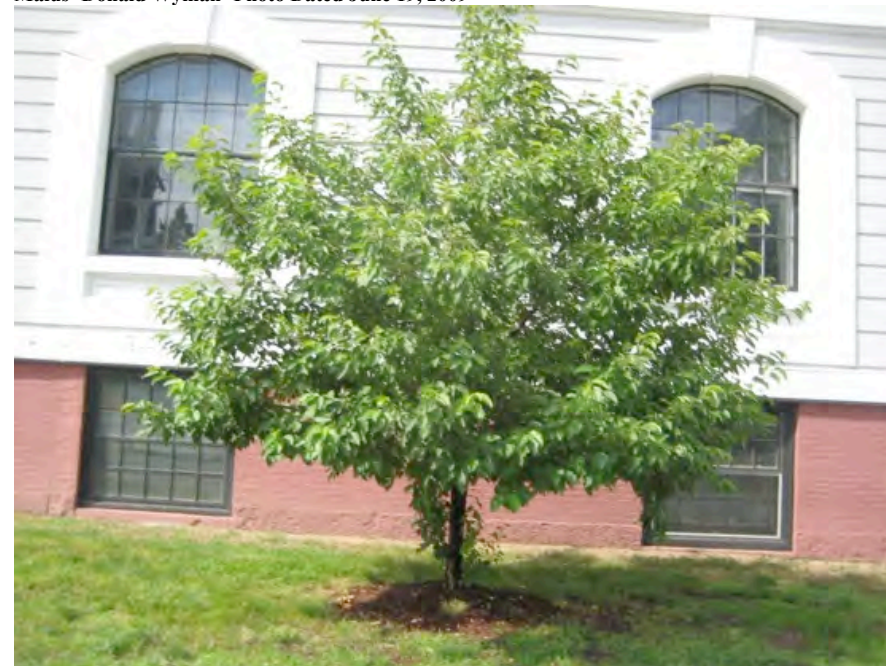
**Malus 'Donald Wyman' Photo Dated June 19, 2009**

Tree has many suckers which need to be removed. Some insect damage to leaves. General good health.

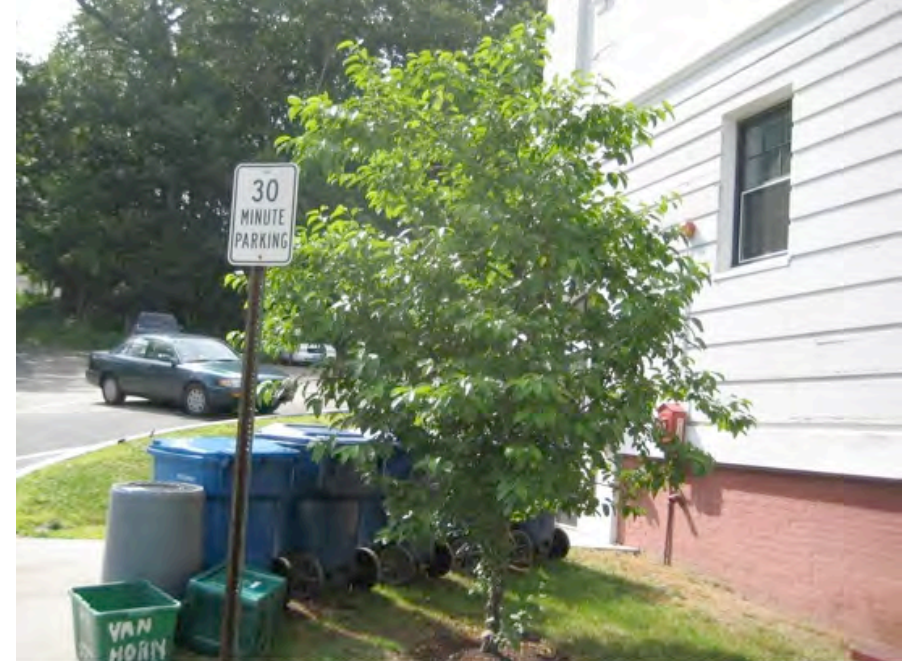
**Malus 'Donald Wyman' Photo Dated June 17, 2009**

Suckers on trunk need to be removed along with the mulch covering the root flare. There is some insect damage to leaves. It is a fairly healthy tree.

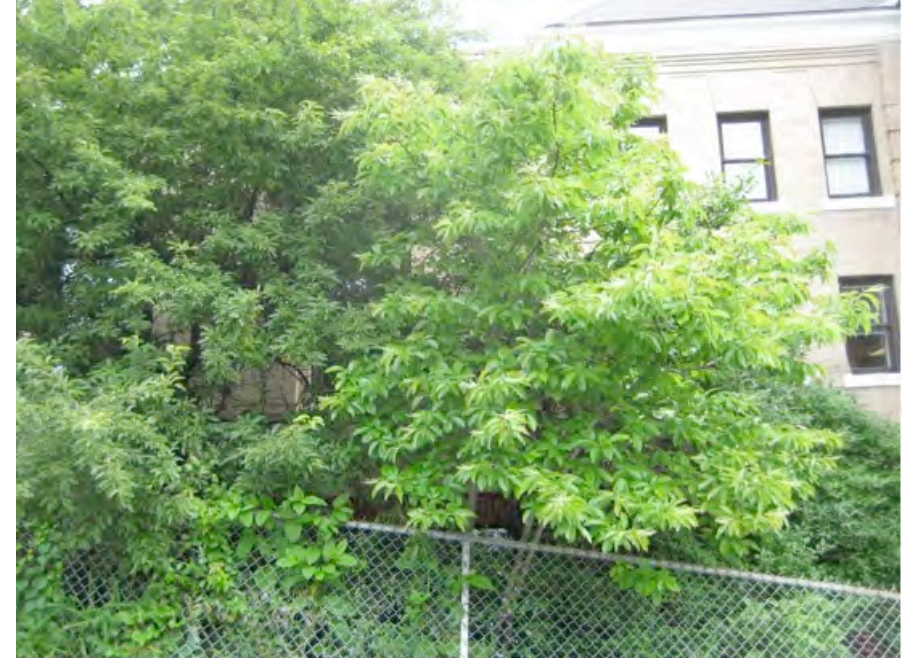
**Oxydendrum arboreum, Photo Dated June 26, 2009**

This multi-trunk tree appears healthy, especially on the side away from the Library where it is open to the light. The other side is encroached by the malus. In general, the tree needs suckers removed, heavy pruning to give it shape and freedom from other plants, and mulch removed from the flare. The chain link fence is falling against the tree and other plants, and should be repaired or replaced.
