# **TREE SURVEY 2010**

### Of Trees Planted by the Holliston Garden Club 1953-2010

**The Holliston Garden Club  
P. O. Box 5812  
Holliston, MA 01746**

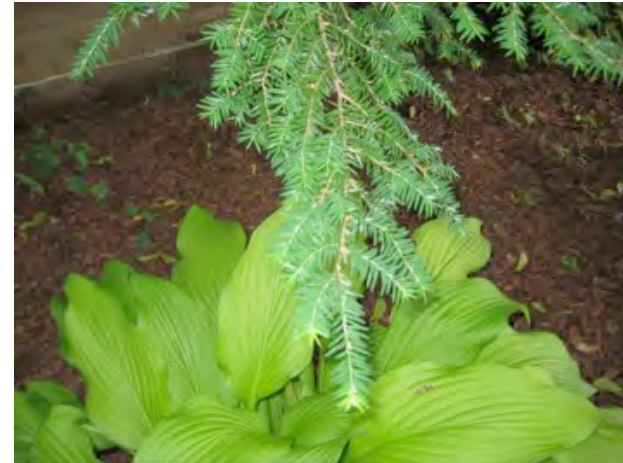
The tree has two trunks. Recommend removing one trunk to allow for light and better growth and appearance; or, to create a better environment for all the trees, remove this one completely. This would create better conditions for the Ginkgo biloba next to the hemlock. The tree is not particularly attractive and adds little to the area, which is already too narrow to support so many large trees.

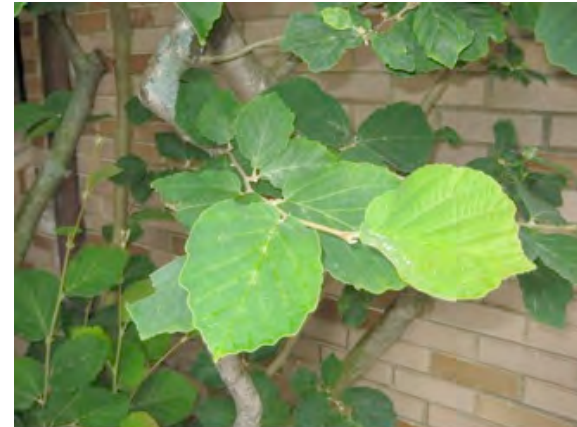
Multi-trunk tree, with some suckers that need to be removed. Tree also needs heavy pruning as it has outgrown its space. The planting area should be enlarged and the soil replaced, then mulched. The tree blooms every winter and makes a nice display, so it appears to be healthy.

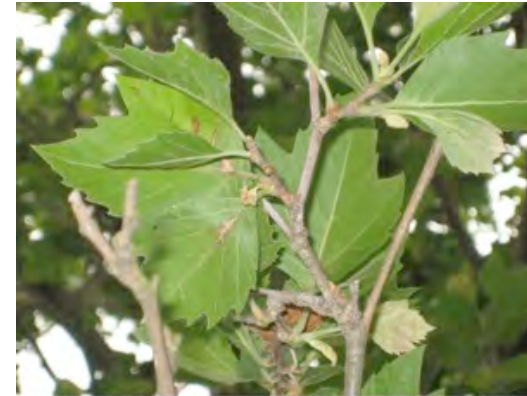
Species: <span style="border: 1px solid black; padding: 2px;">Platanus acerifolia</span> , Sycamore, Plane	Wounds/Cavities:	Yes	No
		X	X
Address: Holliston Public Library 752 Washington St.	Leaning:	X slightly	
Location at Addr: To right of front lawn	Utility Wires:		X
Hardware: No	HGC Donated:	X	
Mulched: Yes	% Missing Canopy:		0
Vines on Tree: No	% Dead Canopy:		0
Tree flare or trunk exposed properly: Partially exposed - needs more uncovering

Tree is lovely, good condition but needs some pruning.

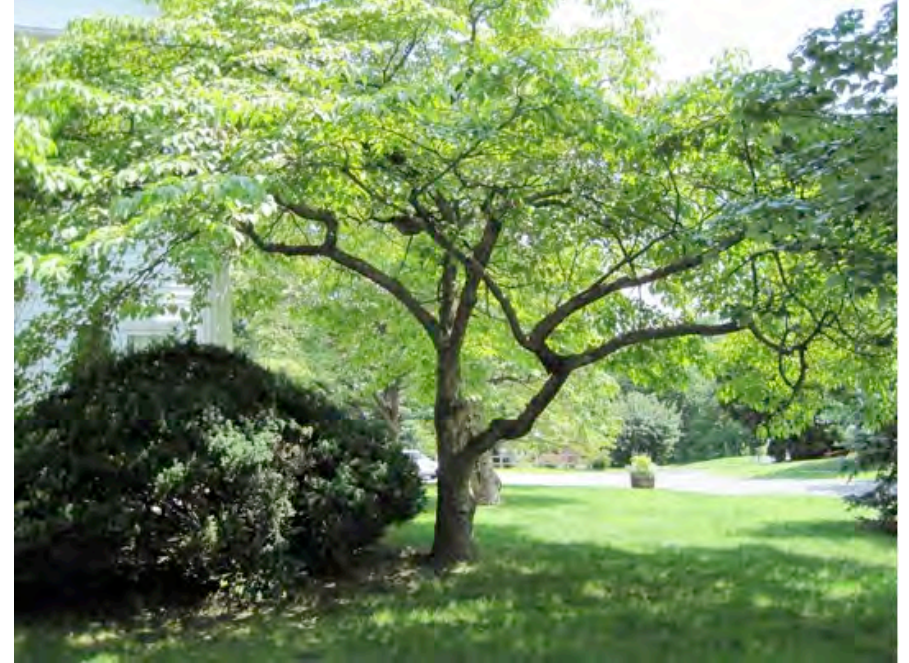
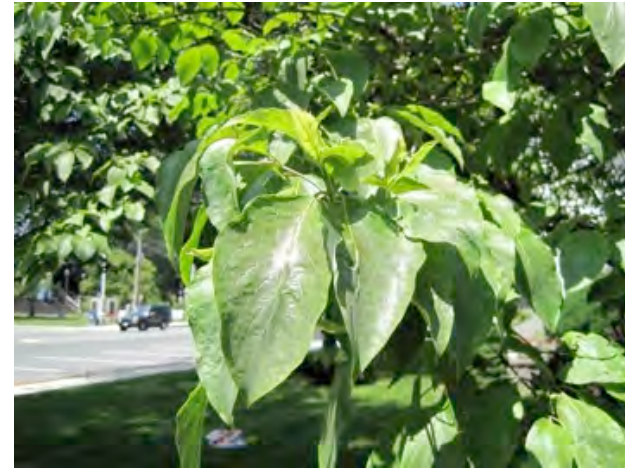
**Cornus florida, Photo Dated July 17, 2009**

Species: <u>Cornus florida</u> , Flowering Dogwood	Wounds/Cavities:	Yes	No
			X
Address: St. Mary's Rectory	Leaning:	X	
8 Church Street			
Location at Addr: Right of front door	Utility Wires:		X
Hardware: No	HGC Donated:	X	
Mulched: No	% Missing Canopy:		X
Vines on Tree: No	% Dead Canopy:	25%	
Tree flare or trunk exposed properly: No

Fairly healthy tree but some branches are missing. The tree leans slightly, adding to its interest. There are many berries.

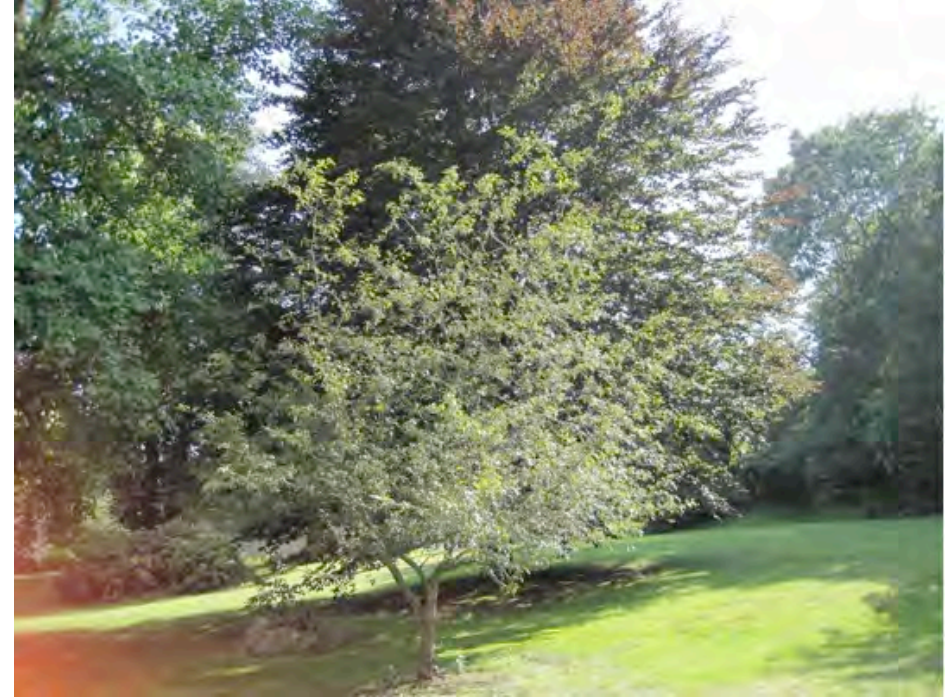
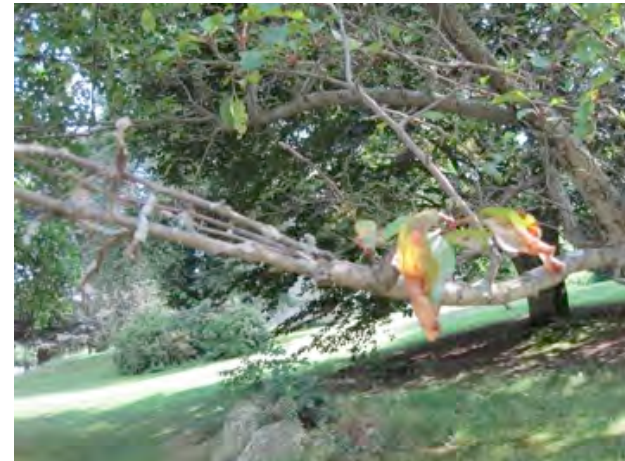
**Malus Photo Dated July 30, 2009**

Species: <span style="border: 1px solid black; padding: 0 2px;">Malus</span> , Crabapple 'Henrietta Crosby'	Wounds/Cavities:	Yes	No	
Address: Holliston Historical Society 547 Washington St.	Leaning:		X	
Location at Addr: Right side of driveway on main building side of property	Utility Wires:		X	
Hardware: No	HGC Donated:	X		
Mulched: No	% Missing Canopy:		X	
Vines on Tree: No	% Dead Canopy:	30%		
Tree flare or trunk exposed properly: Yes

Tree appears to be dying from fungus and other illnesses. The leaves are small and marked, there are missing leaves on the branches and galls on some branches. The absence of leaves is about 30% of the canopy. Tree probably is beyond help and should be removed.

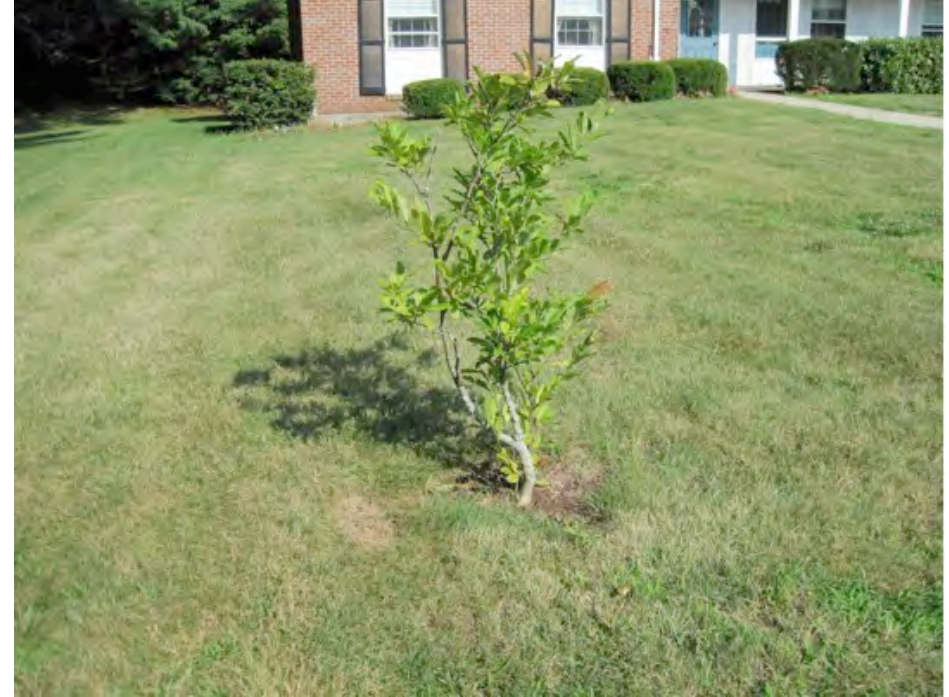
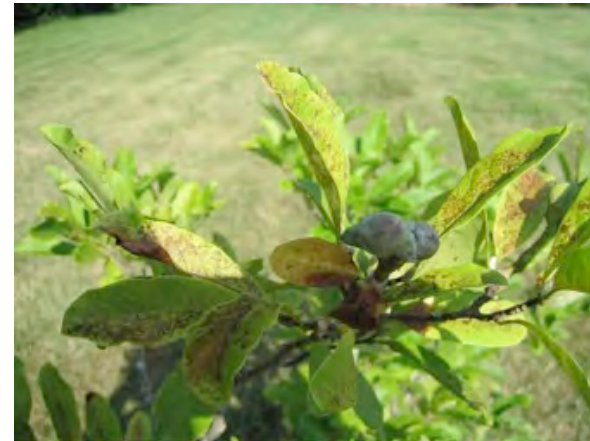
**Magnolia x loebneri, Photo Dated July 30, 2009**

Yes	No
Species: <u>Magnolia x loebneri</u> , 'Leonard Messel'		
Magnolia		X
Address: Cole Court Senior Apts.		
Washington St.		X
Location at Addr: Left rear as you face the back		
Utility Wires:		X
Hardware: No	X	
HGC Donated:		
Mulched: Yes		X
% Missing Canopy:		
Vines on Tree: No		X
% Dead Canopy:		
Tree flare or trunk exposed properly: Partly exposed

The tree is diseased and growth is stunted. There is rust on the leaves and fungus on the trunk.

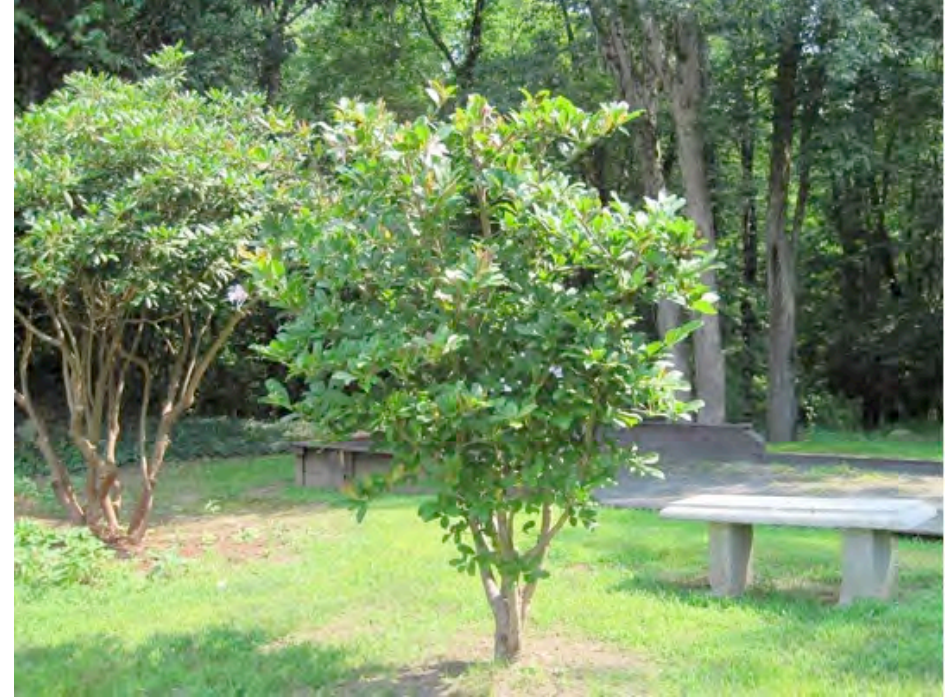
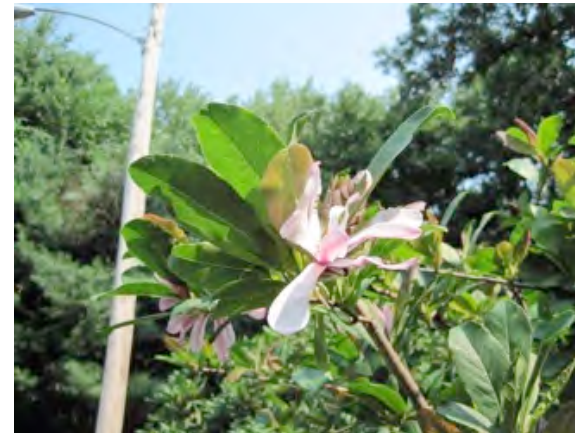
**Magnolia x loebneri Photo Dated August 5, 2009**

*Describe tree health, soil condition (compacted, gravel, etc.) pit size, and if it is cemented in.*  
Multi-trunk, healthy small tree. Has been pruned often to maintain compact, thick canopy. Growing in the sun, it even had a few flowers in August.

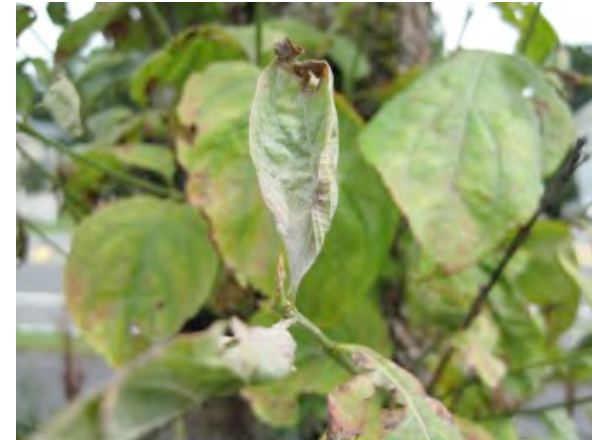
Sickly, with many missing branches. The bottom two feet of the tree appear rotted.

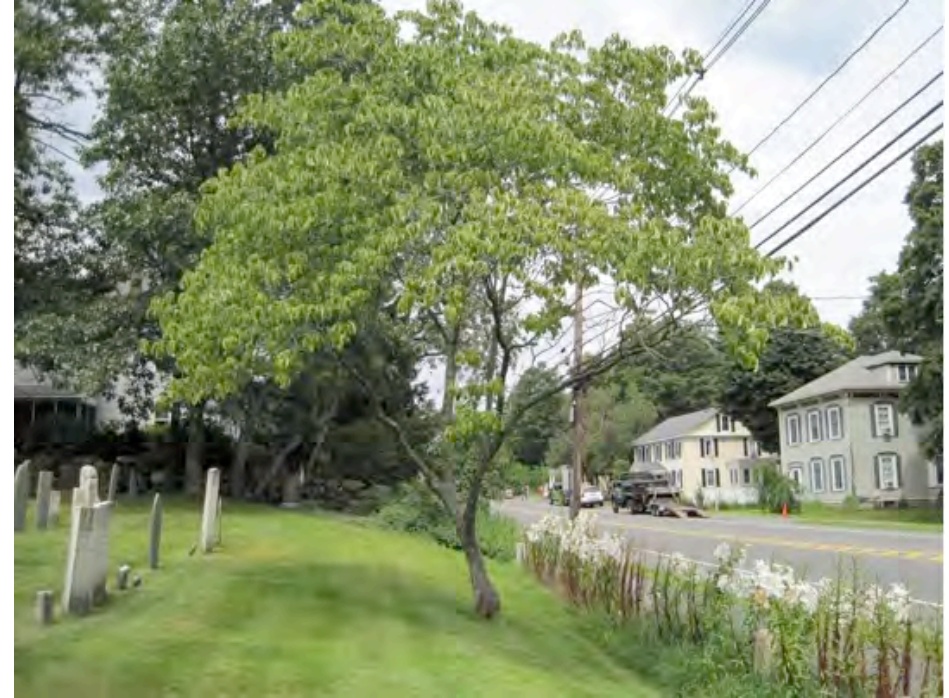
**Cornus florida, Photo Dated August 6, 2009**

Nicely shaped, balanced tree with some missing branches and defects due to aging.
